**Executive Summary:**

**Site/Project Location:** Watford City Terminal

**Date of Inspection:** 22 November 2016

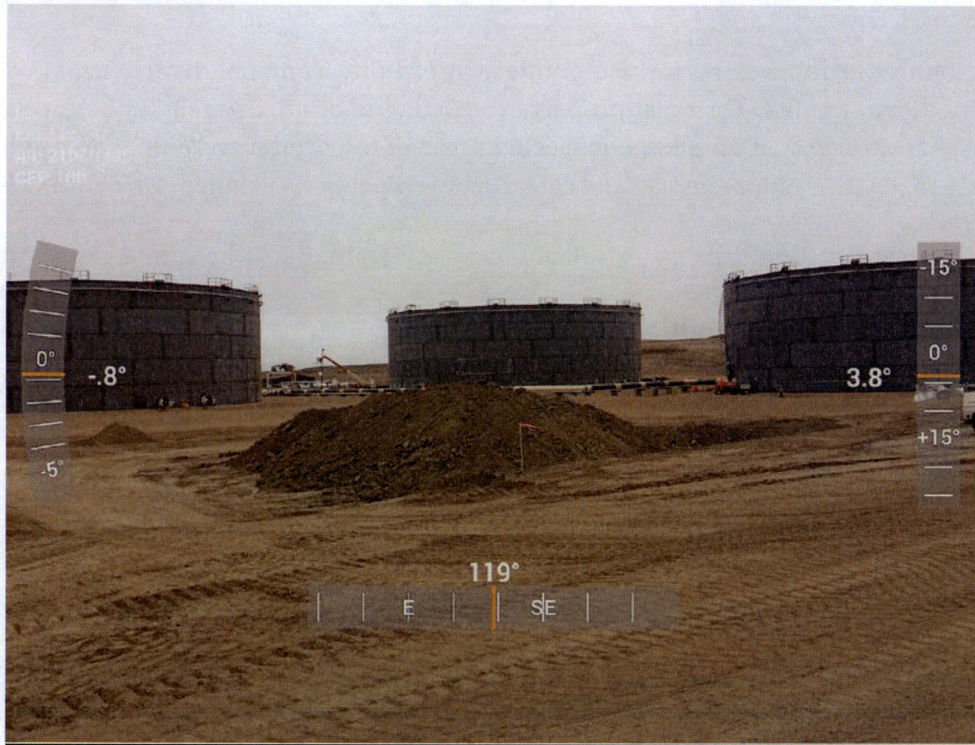
Construction crews were active. The three large tanks are being constructed along with associated facilities at the terminal. Care was taken around terminal boundaries.

**Report Photo #1 Tanks Under Construction**

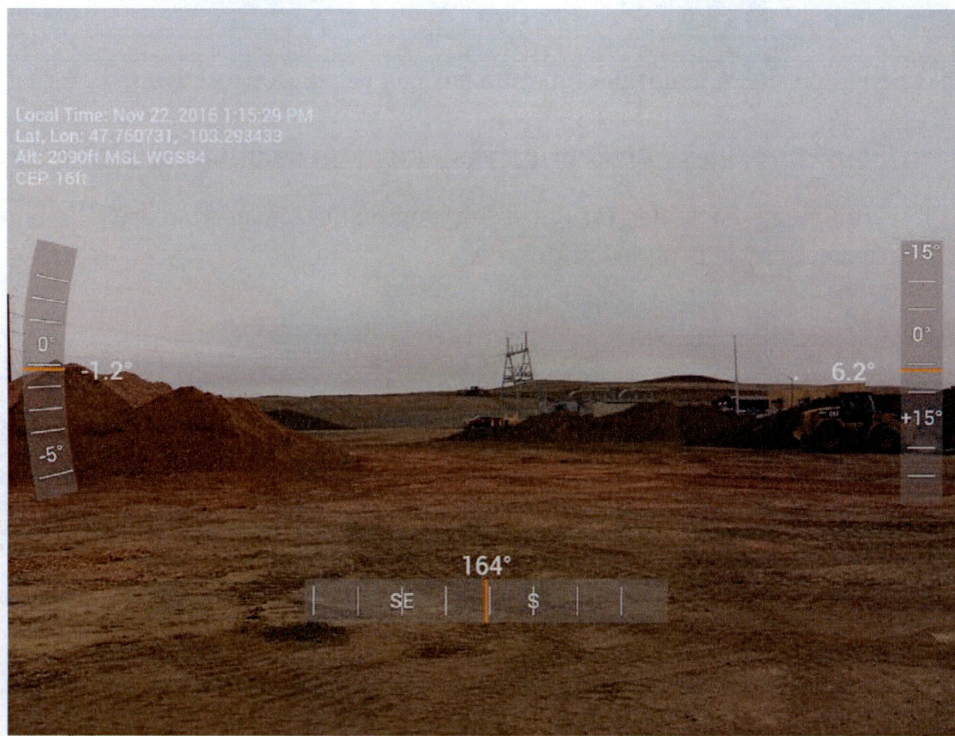
Topsoil and subsoil segregation appeared adequate throughout the inspection area. No evidence of topsoil and subsoil mixing or improper replacement was noticed. Erosion controls had been installed near culverts, slopes, and drainage pathways. Erosion control measures all appeared to be in good repair and working properly.

**Report Photo #2 Scoria and Subsoil Piles Separated**

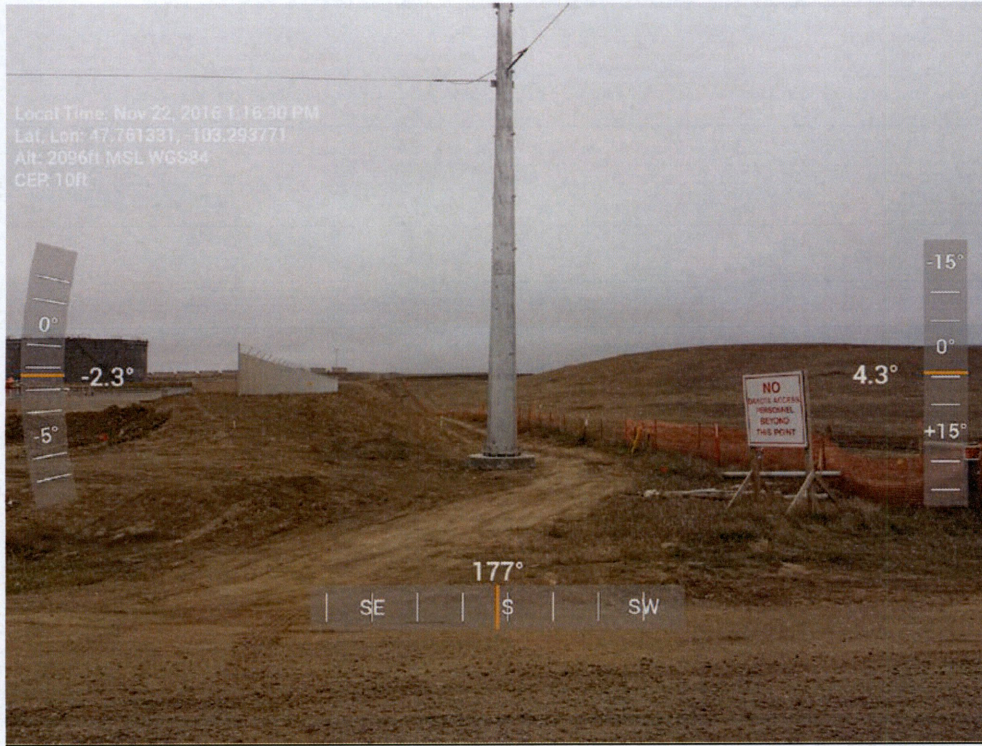
**Report Photo #3 Defined Perimeter of Watford City Terminal**

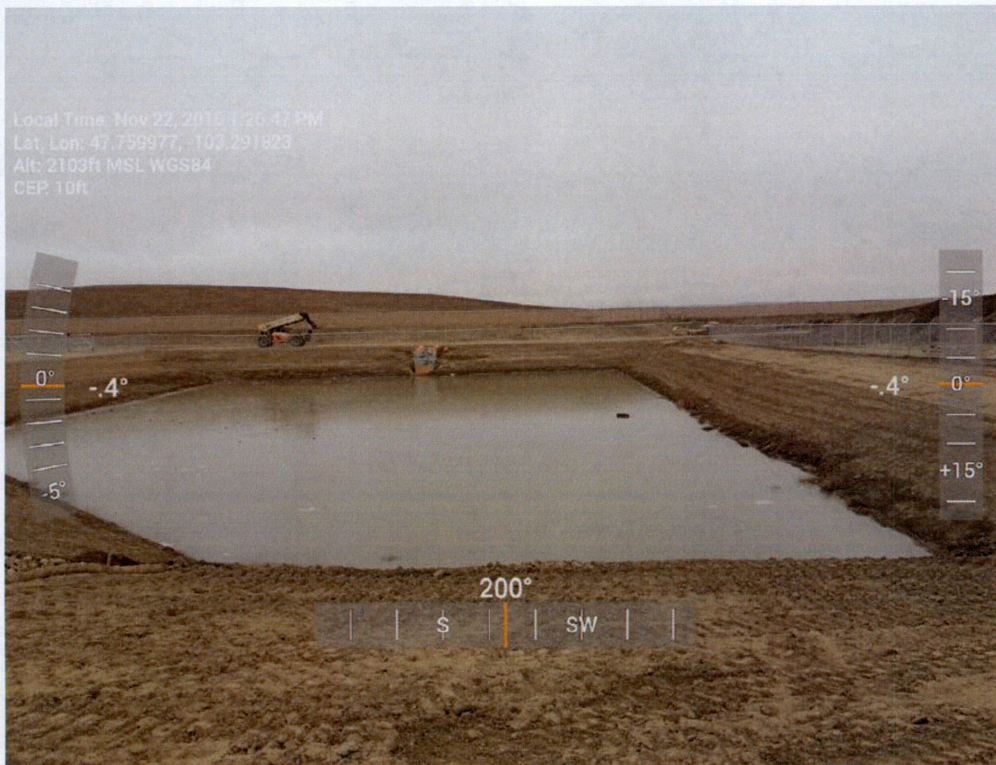
**Report Photo #4 Stormwater Retention Pond**

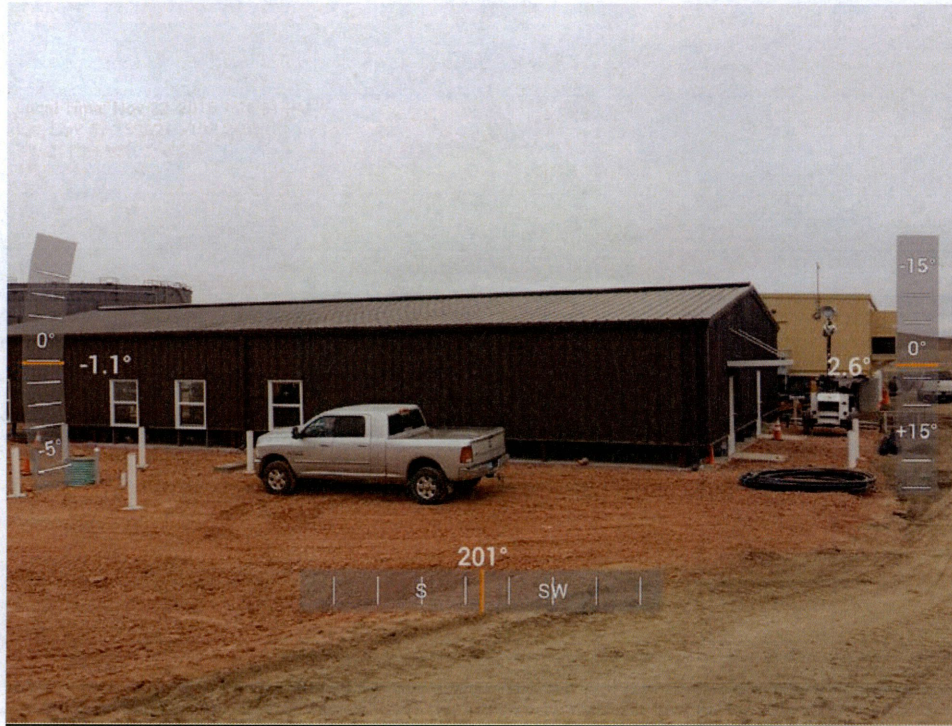
**Report Photo #5 Terminal Facility Buildings Under Construction**
